**Loss of Pitch Control During Takeoff  
Air Midwest Flight 5481  
Raytheon (Beechcraft) 1900D, N233YV  
Charlotte, North Carolina  
January 8, 2003**

**Aircraft Accident Report**  
**NTSB/AAR-04/01**

**Air Midwest Flight 5481**

**Raytheon (Beechcraft) 1900D, N233YV**

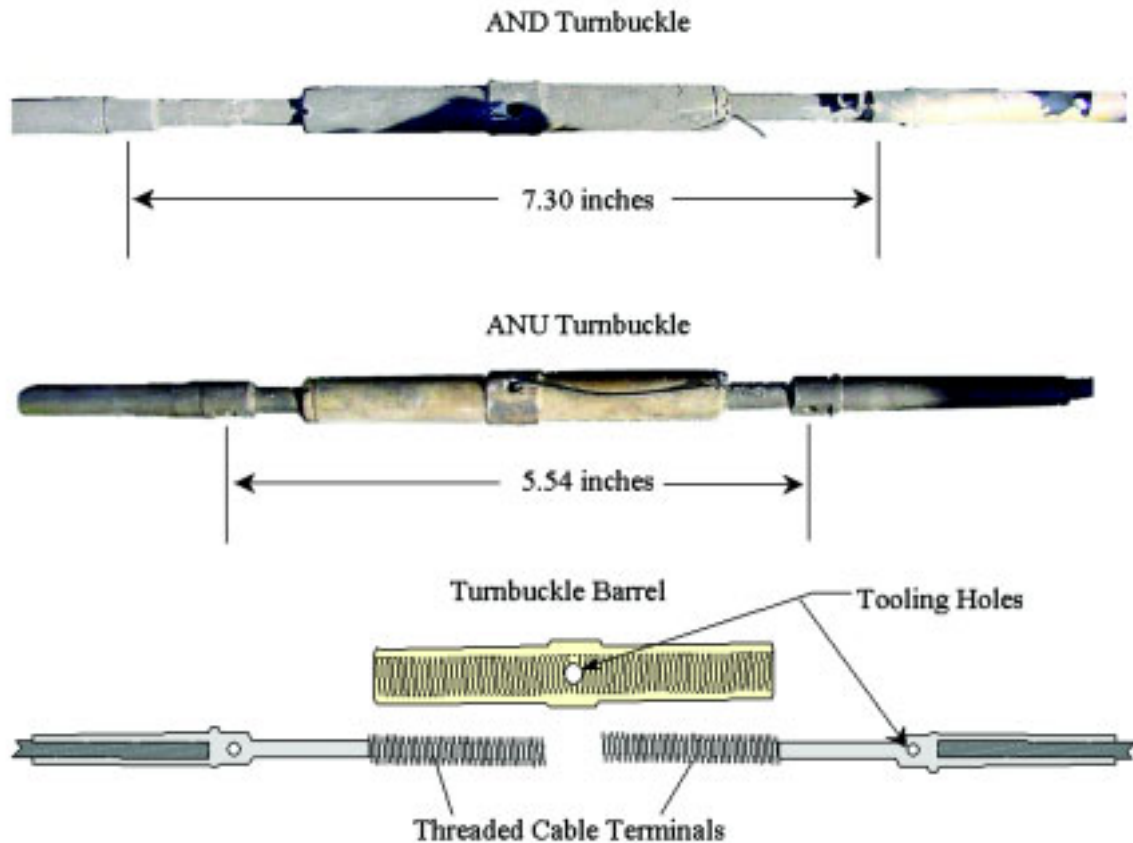
The ANU turnbuckle was almost fully contracted, and the AND turnbuckle was almost fully extended. The measurement from the center of the tooling hole in one threaded cable terminal to the center of the tooling hole in the other cable terminal was 5.54 inches for the ANU turnbuckle and 7.30 inches for the AND turnbuckle. In addition, the AND turnbuckle had one thread visible, and the ANU turnbuckle did not have any threads visible. Figure 6 shows the turnbuckles as found in the wreckage and a drawing that shows a turnbuckle barrel and threaded cable terminals.

**Figure 6.** Turnbuckles as found in the wreckage.

The AND turnbuckle was extended 1.76 inches more than the ANU turnbuckle. After the accident, Air Midwest surveyed its entire fleet of 42 Beech 1900D airplanes, which represented 25 percent of the 164 Beech 1900D airplanes active in the North American fleet. Air Midwest data submitted to the Safety Board indicated that, on average, the AND turnbuckle was extended 0.04 inch less than the ANU turnbuckle.

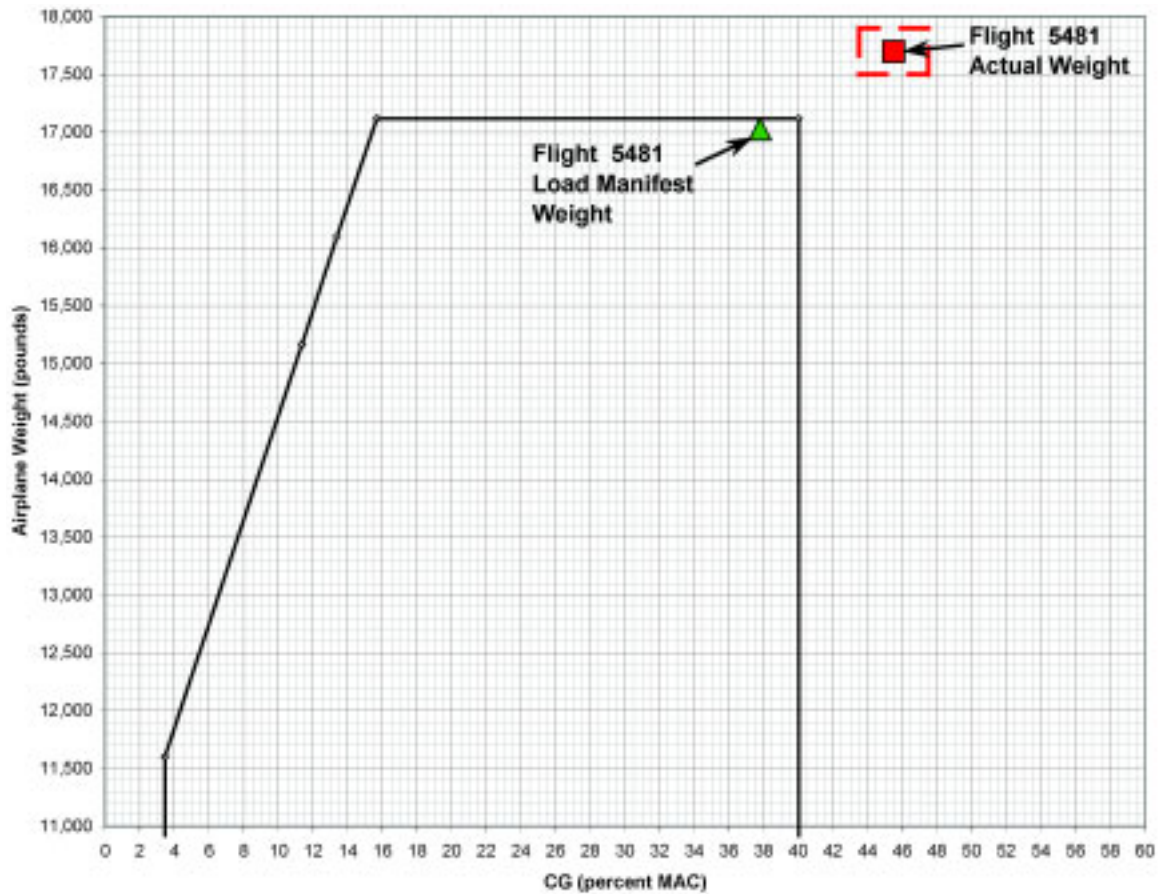
On the basis of these FDR data, radar data, the validated force and moment model, and component weight and location information, the Safety Board determined that the accident airplane had an actual weight of  $17,700 \pm 200$  pounds and an actual CG position of  $45.5 \pm 2$  percent MAC. Figure 7 shows the results of the Board's calculations overlaid on the Beech 1900D weight and CG envelope.

Figure 7. Weight and center of gravity information for flight 5481.

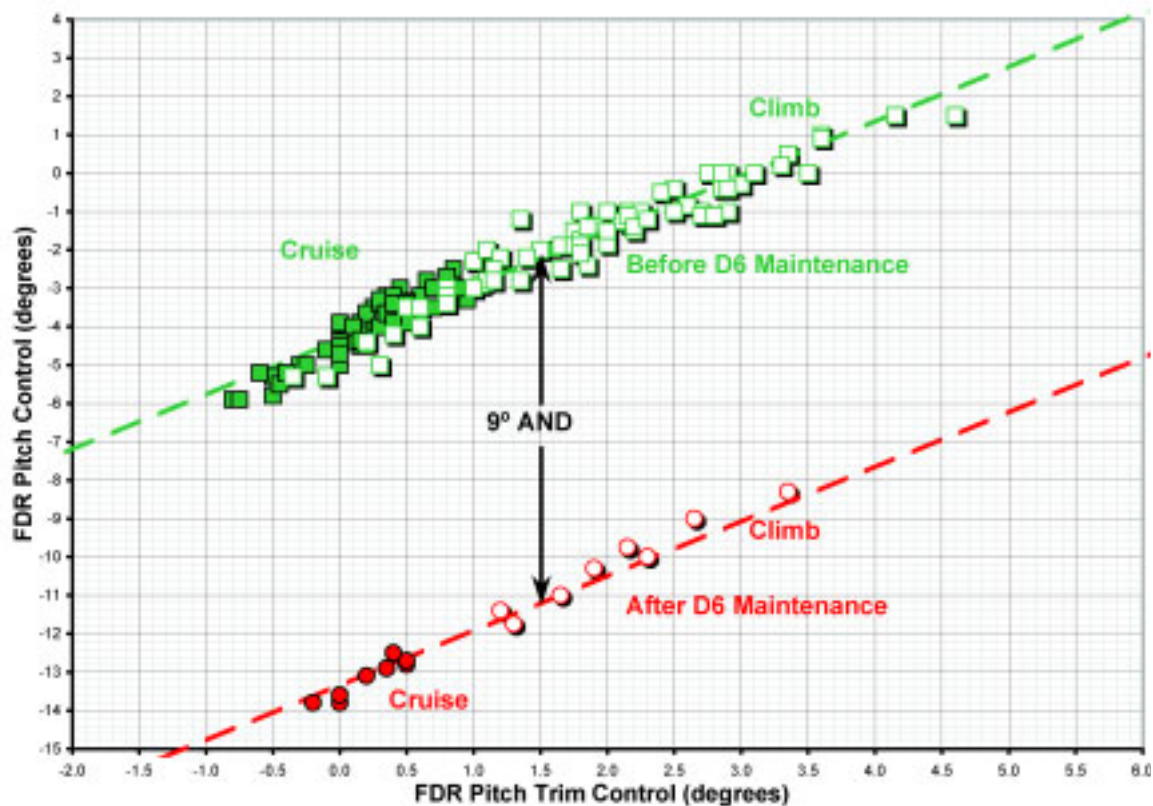
The position of the trim tab is the predominant predictor of elevator position during climb and cruise flight. Figure 8 shows that a strong correlation exists between elevator (FDR pitch control position) and trim tab (FDR pitch trim control) data. The figure shows two distinct data groups: the larger group represents flights before the D6 maintenance check, and the smaller group represents flights after the D6 maintenance check.

**Figure 8.** Flight data recorder pitch control and pitch trim control positions.

The larger group of data shown in figure 8 (that is, the flights before D6 maintenance) compared well with the Beech 1900D flight test certification data, indicating that the pre-maintenance FDR pitch control position data represented the actual elevator position to within about 1°. However, the smaller group of data (that is, the flights

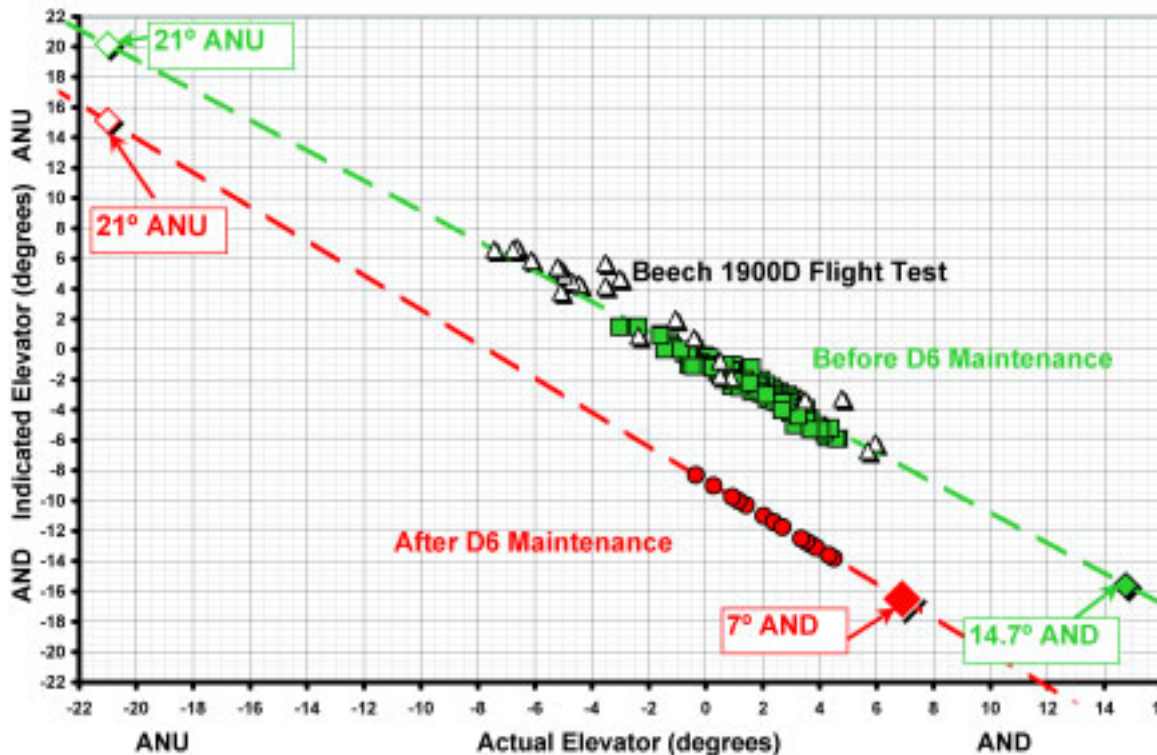
**Figure 9.** Elevator travel available before and after the detail six maintenance check.

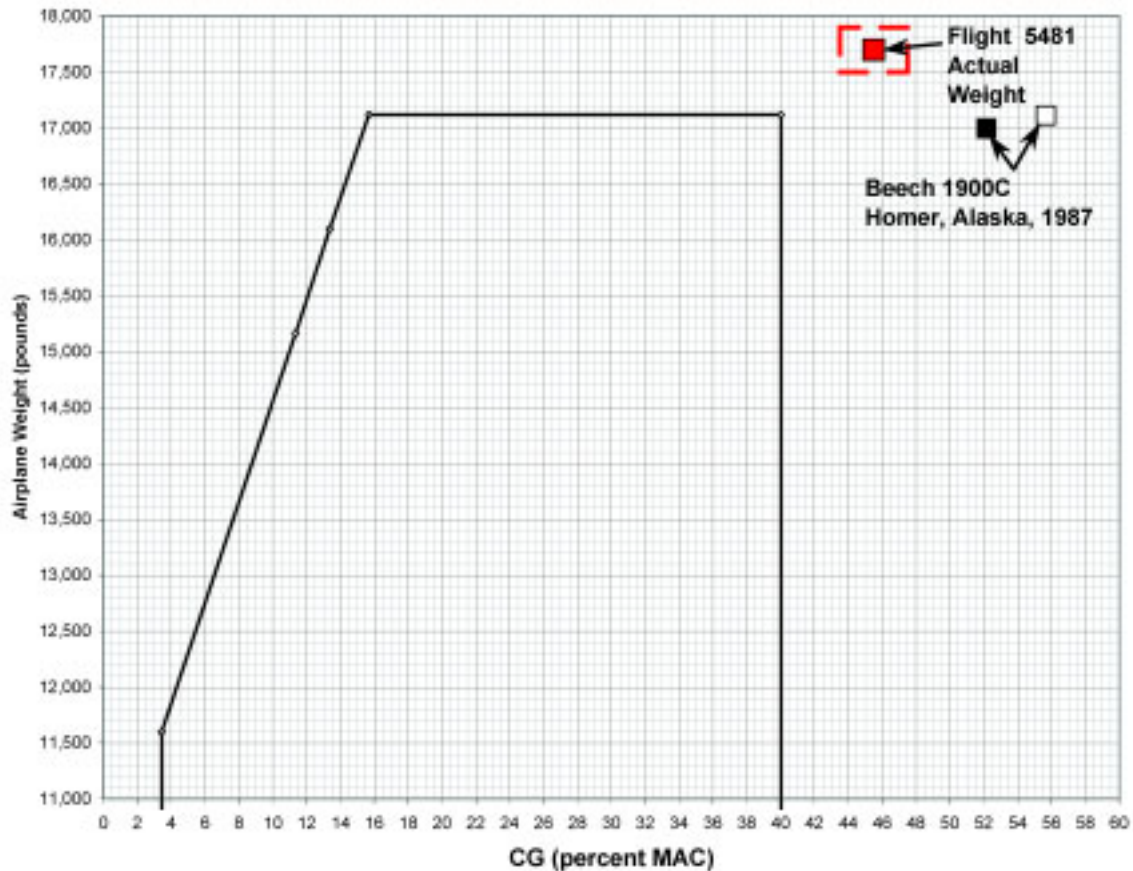
Figure 11 shows flight 5481's weight and CG information compared with that for the flight 103 accident airplane. Two data points in the figure show the CG range for the flight 103 airplane.

**Figure 11.** Flight 5481 weight and center of gravity information compared with flight 103 weight and center of gravity information.
